Repairing Corroded Injection Water Pipes in the Cooling Tower of CSR Macknade Sugar Mill

Project 868

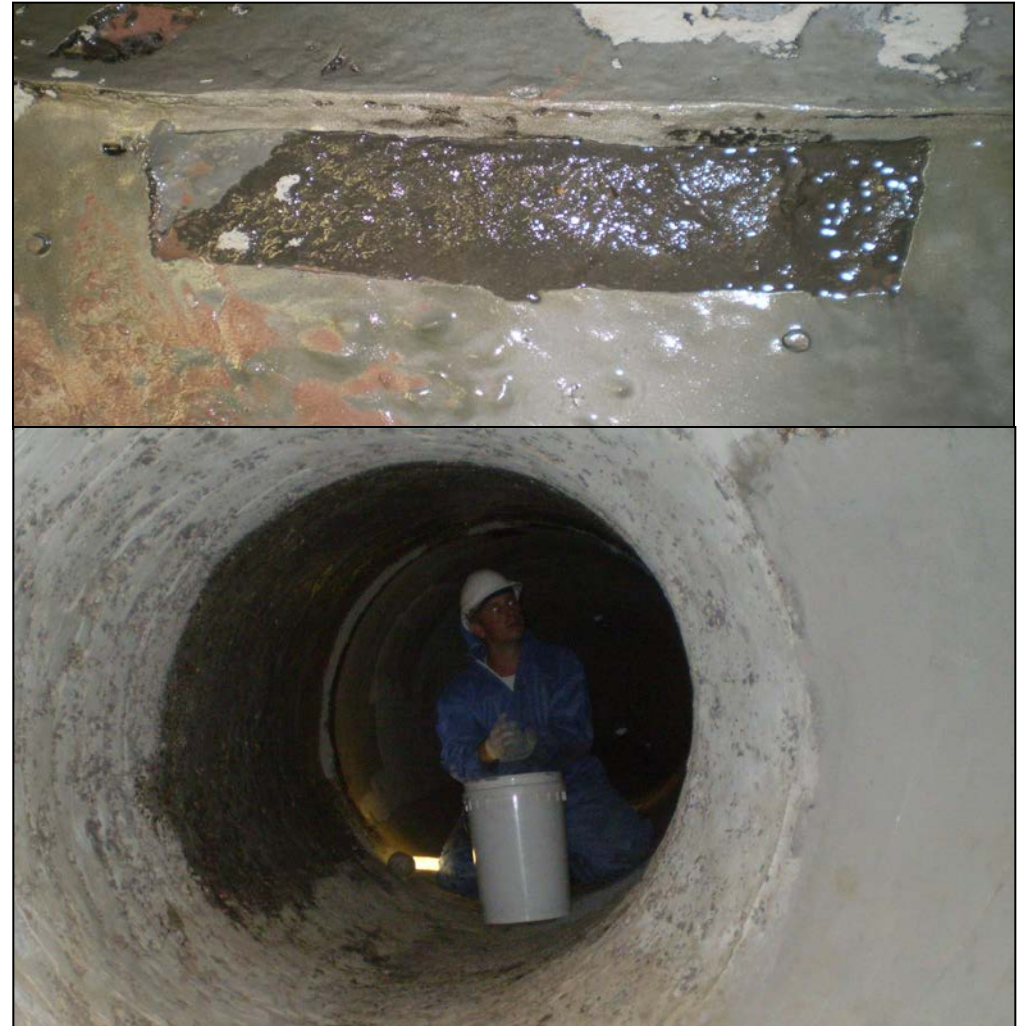
- During preliminary blasting, prior repairs that were found used mixed products (30mm thick)
- Water was seeping in during blasting, where large sections of steel were missing
- All leaks and pin holes had to be repaired/plugged

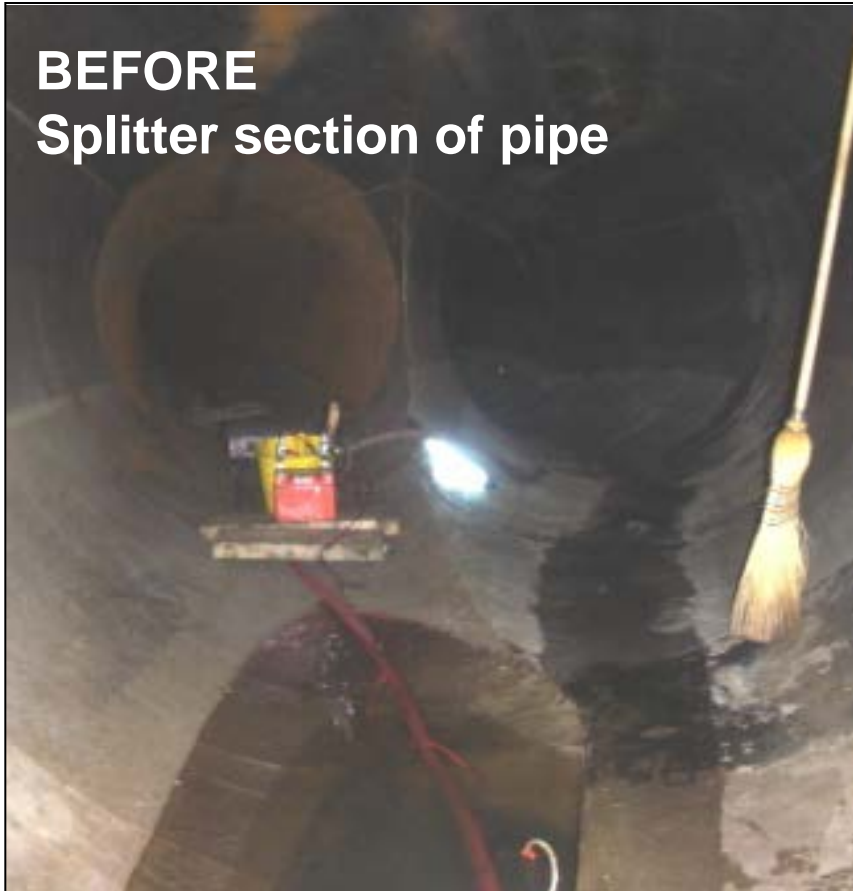
BEFORE
Splitter section of pipe

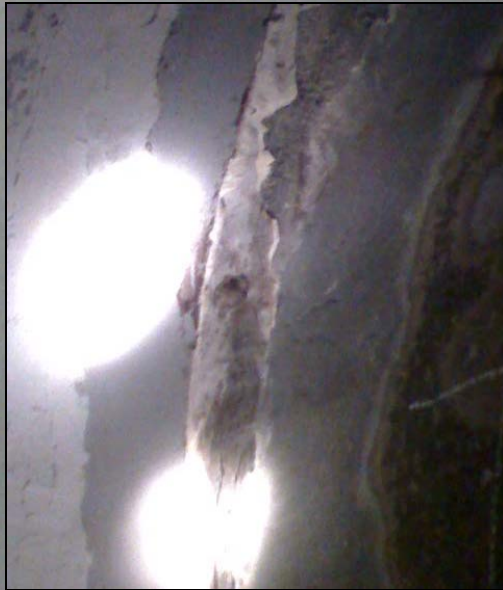
**EXPOSED REINFORCED STEEL
SPONGE BLASTED FOR RECOATING**

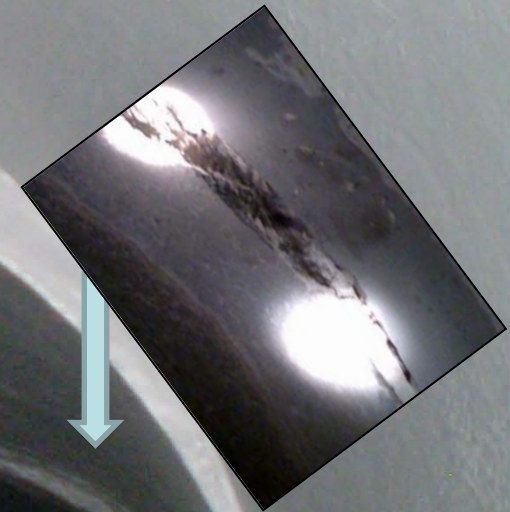
**SPONGE BALASTED
JOINER FOR REBUILDING
BETWEEN CONCRETE
AND STEEL**
