# Restoration Corner

## Disaster Update-Governor's Mansion Update

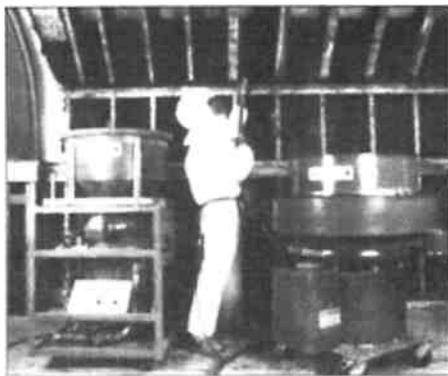
Portable ozonators can be used in homes or offices where odors need to be eliminated. The area must be sealed off and all occupants, pets and plants are vacated while high concentrations of

ozone are generated. Although no one has become seriously ill or died from over exposure to ozone, it is recommended to wait 30 minutes after the ozone generator has been turned off before re-entering the room. Ozone leaves no residue or toxic byproducts behind as it naturally converts back to oxygen in a matter of minutes, just simple ventilation is all that is required for its removal. **Ozone is not a cure-all for all odors.** There are specific applications ozone works well on and others that it has no effect on.
