Adhesive Removal from Regeneration Vessel Interiors at Progress Energy Brunswick U2

Project 828

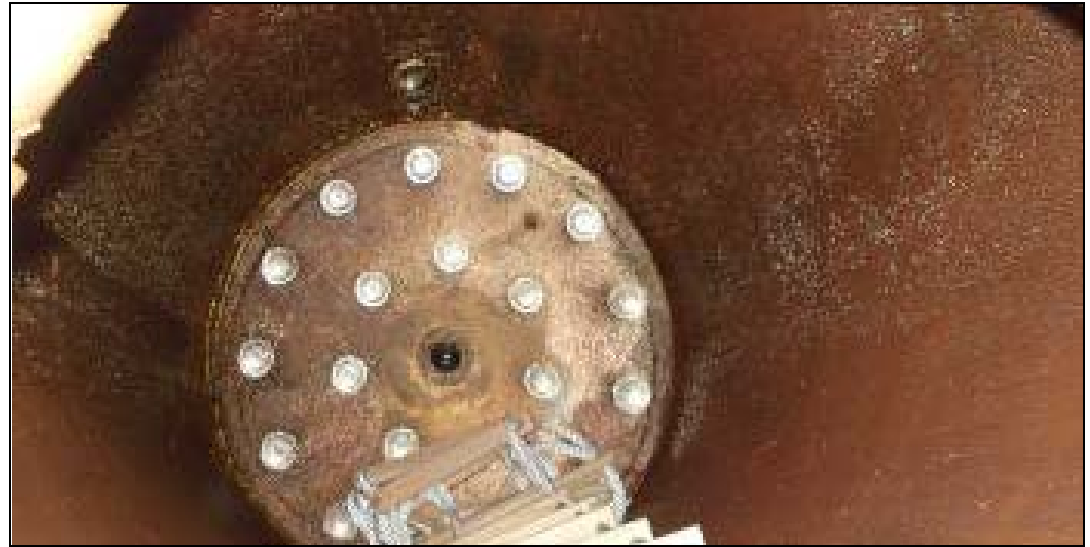
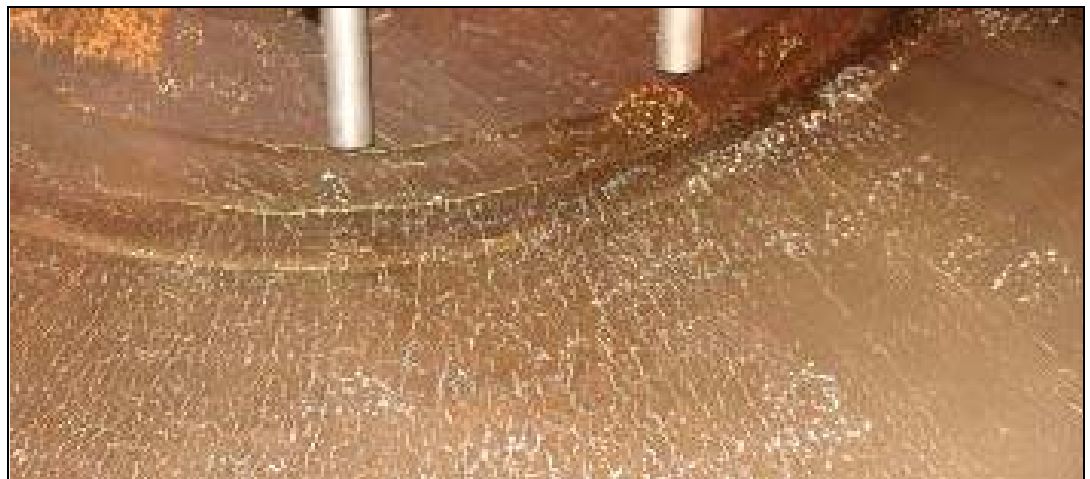
- Three regeneration vessels (a.k.a. condensate polishers)
- Vessels had rubber linings removed using pneumatic chipping hammers
- An adhesive residue remained on the surface
- Small, narrow tank shape; normally a messy process with poor visibility

- Remove adhesive residue
- Prepare surface for paint
