Restoring Structural Steel Girders in Stirling Castle's Elphinstone tower

Project 863

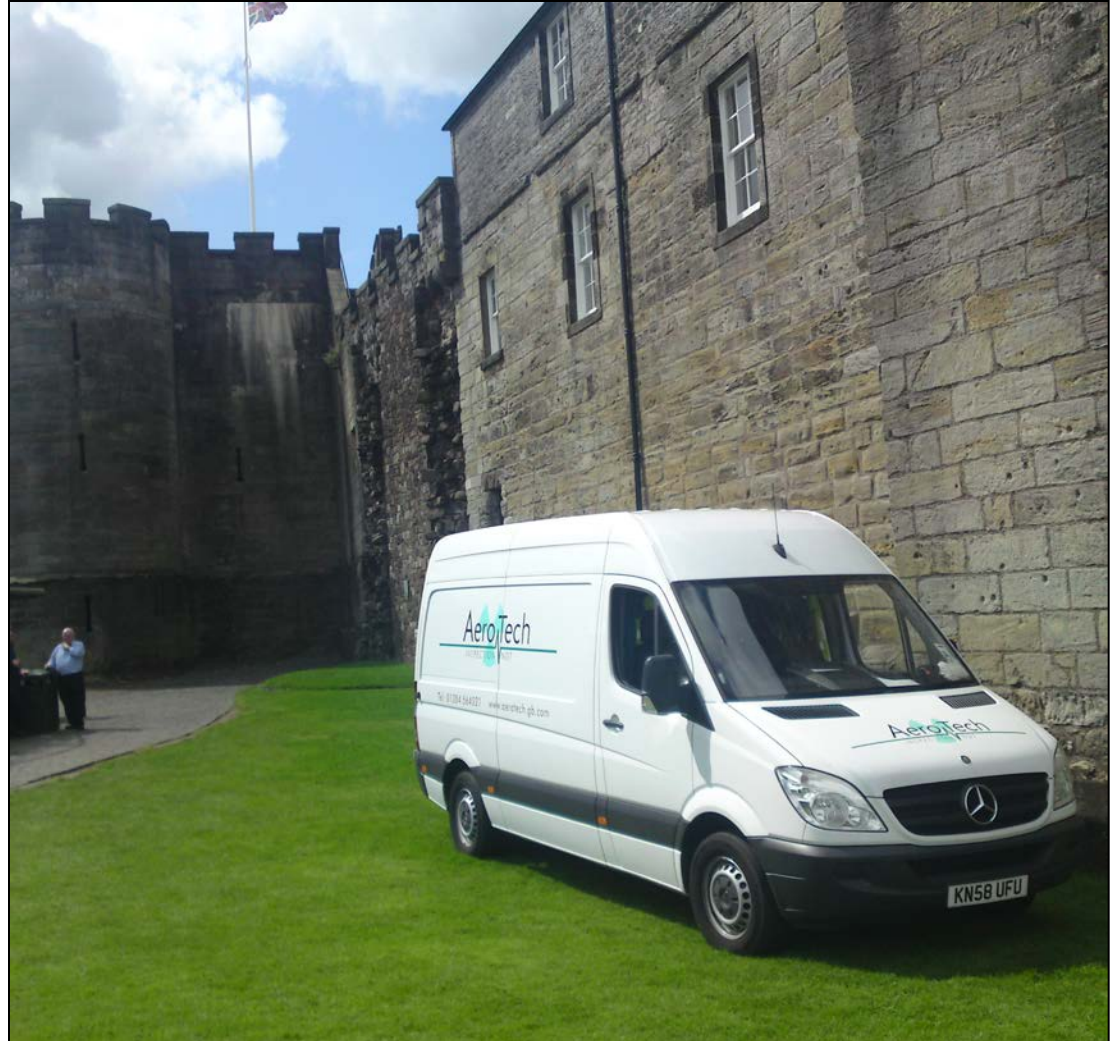
- 12th Century Scottish castle protected by Historic Scotland
- Concrete layer covering structural girders in Elphinstone tower flaking, revealing heavy corrosion
- Management specified stripping to bare metal and recoating
- Limited work schedule to accommodate museum days of operation (365 days/year)

Blasting and painting without interruption to museum

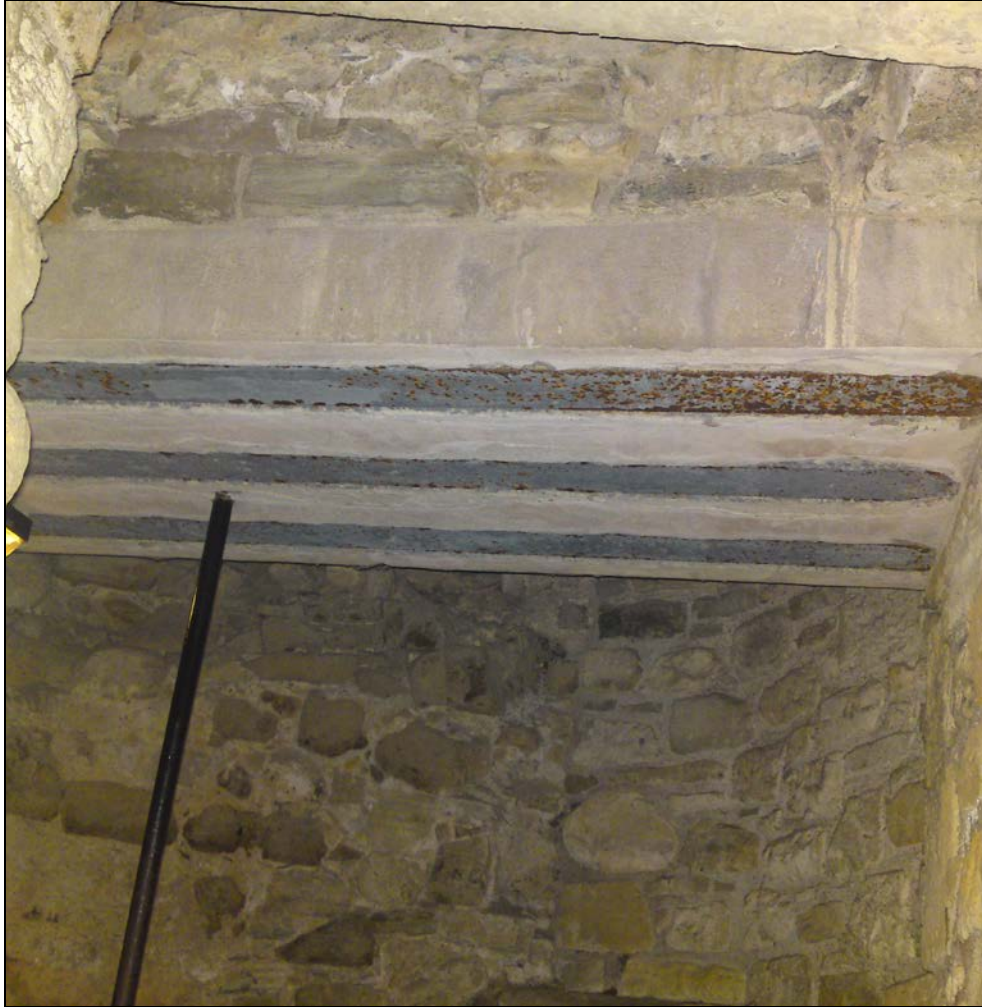
Substrate: steel

Size: (3) 1.5m(5ft) long by
0.25m(1ft) wide

Surface Condition: peeling paint;
heavy corrosion

Level of Specified Cleanliness:
SA 2.5 / SSPC SP-10 / NACE 2
Near-White Blast Cleaning

Profile: 50-75micron (2-3mil)

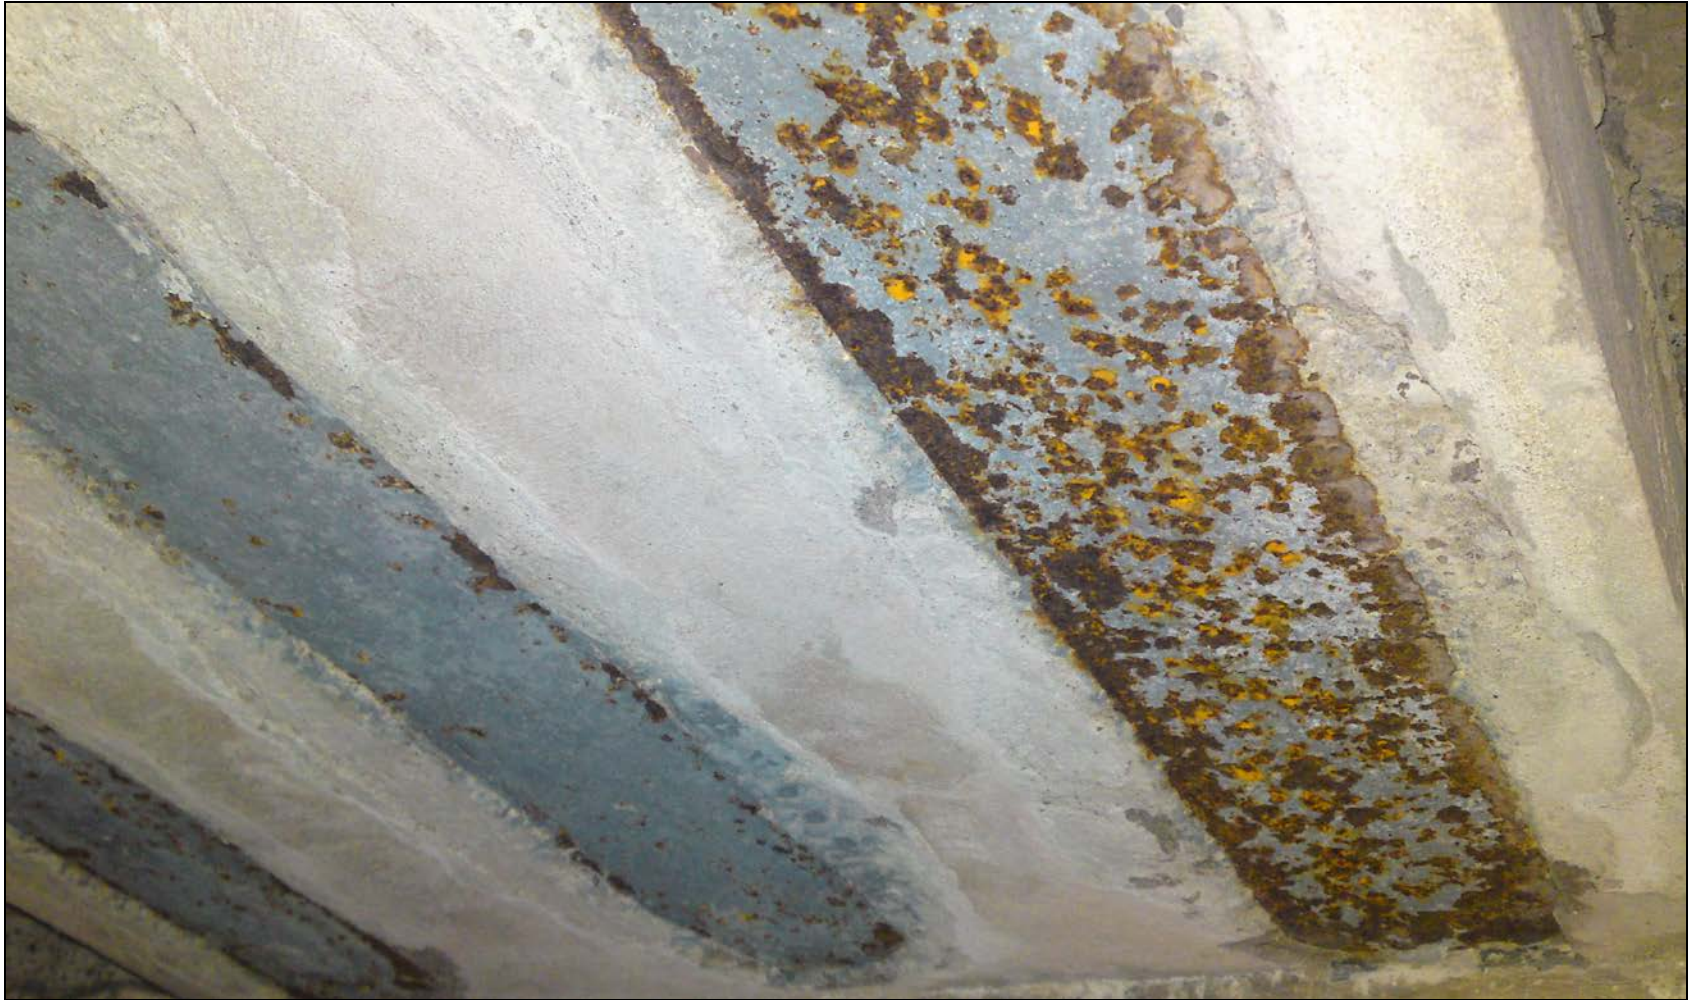
- Girders to be blasted without damaging nearby concrete/stone
- Blaster could see clearly; didn't run risk of blasting surroundings
- Low dust properties were essential to clean up within scheduled parameters

Production Rate: three girders took 20 minutes to prepare

Used: Silver 30 Sponge Media™ abrasives, 100-HP Feed Unit™, 35-P Sponge-Jet Recycler™

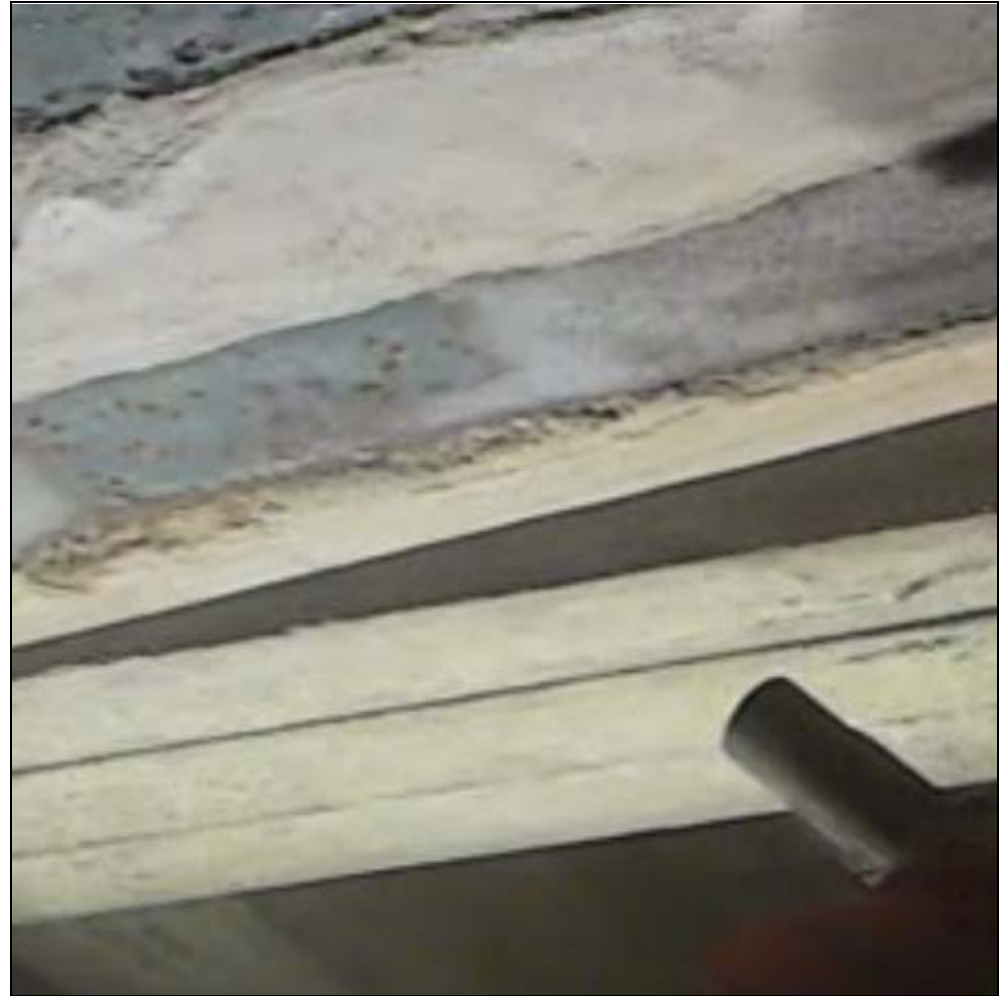
- It took just over 2 hours to cleanup area and dismantle scaffolding and containment
- Project completed at a cost that was well within customer budget

- All requirements were covered
- Historic Scotland stated that they would continue to use on similar projects
