Cleaning and Graffiti Removal on an Amsterdam Brick Building

Maintenance management of an Amsterdam, Netherlands apartment building use Sponge Media abrasives to restore and clean environmental contaminants and graffiti from exterior brick walls

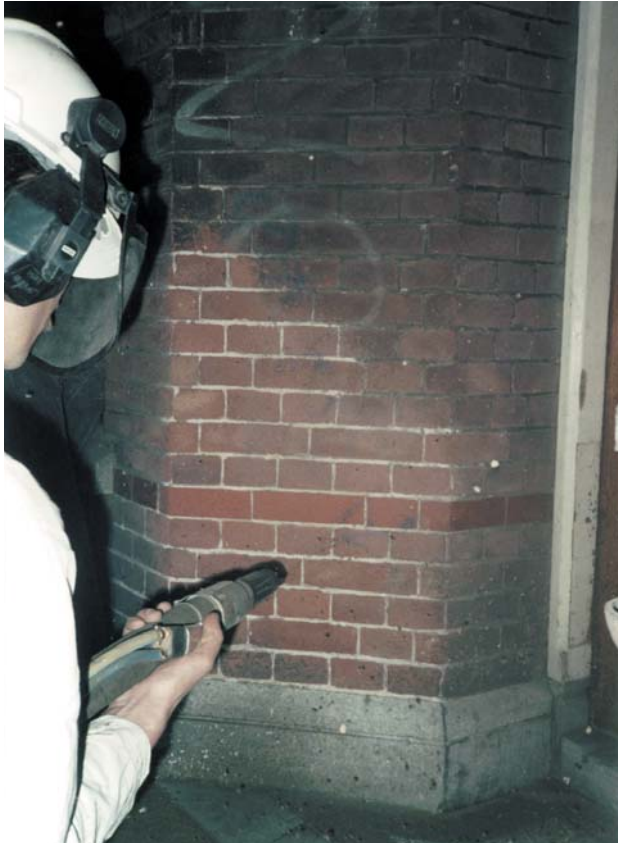
Typical of the early 20th century, a brick apartment building in Amsterdam, Netherlands suffered from environmental contamination. The exterior brick walls and granite blocks of the building accumulated thick, black material and suffered from vandalism.

High pressure wet blasting systems once used to restore the brick and mortar substrate are now being prohibited in fear that associated waste water may contain dangerous chemicals or heavy metal components, which could contaminate surrounding ground water. As a result, Brown Sponge Media™ abrasive, with Dupont® Starblast®, was chosen, by the project contractor, to strip-clean, and rejuvenate the surfaces:

The restoration contractor was able to selectively blast areas of graffiti and discolored brick and stone, with no problems. The optimal blast pressure was between 30 and 45 pounds [2.5 to 3 BAR], with stripping and cleaning rates between four to six feet per hour.
