**ANOTHER PROJECT
DONE BEST
WITH THE SPONGE-JET[®]**

Removal of #6 oil residue from petroleum storage tank exteriors

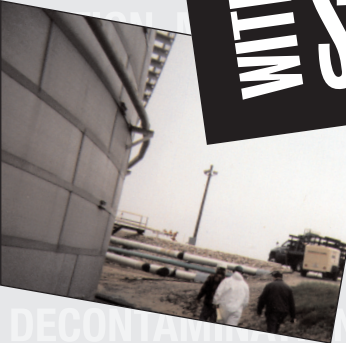
Solution: Using **Sponge-Jet's Sponge Blasting System™**, Clean Harbors was able to efficiently remove the thick oil coating and the residual black stains without causing damage to the aluminum substrate or to the surrounding environment.

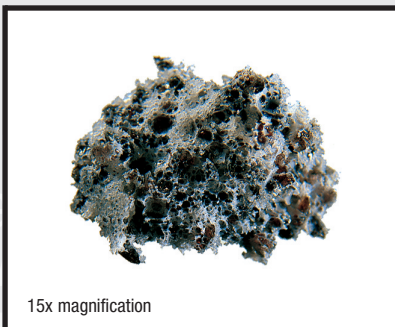
15x magnification

Sponge-Jet® Silver Sponge Media™ featuring MICROCONTAINMENT™ technology

Very low abrasion, light coatings removal, sensitive substrates and composite applications

>25 micron (>1mil)

Aluminum Oxide
