Repairing Corroded Injection Water Pipes in the Cooling Tower of CSR Macknade Sugar Mill

Project 868

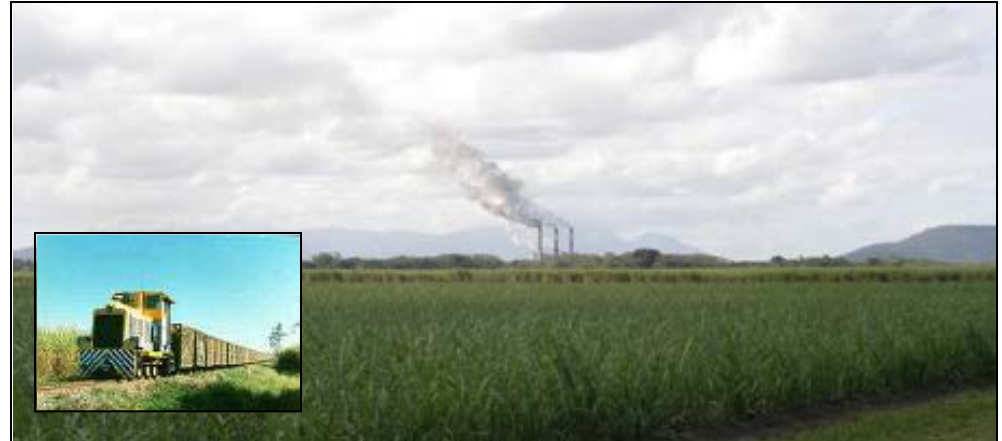
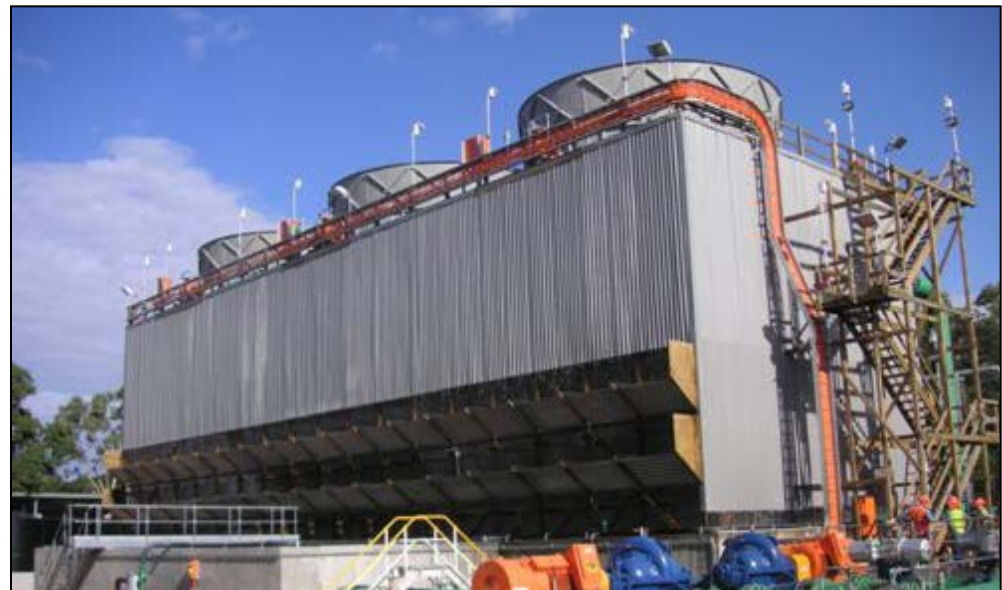
- CSR Sugar Mill, Macknade
- Single "train" mill capable of crushing over 1.5 million tons of sugar cane
- Routine engineering inspection of the cooling tower revealed injection water pipes had been eaten away in places by corrosion

Repair corroded/leaking pipe sections by abrasive blasting and applying high-build composite coating
