Fire Restoration/Renovation in Glass Manufacturing Plant

Moore Restoration Services uses Sponge-Jet Sponge Blasting™ System in ceiling and attic sections of Midwest glass plant to remove soot and charred coatings

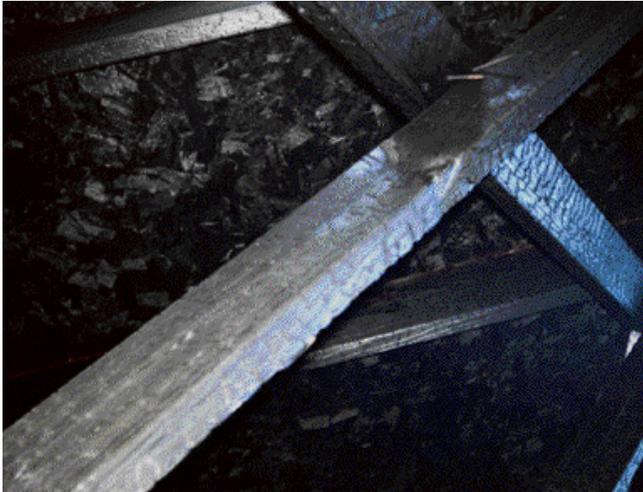
Immediately following a plant fire, facility owners turned to Moore Restoration to remove soot and charred residual coatings. The facility had to reopen as soon as possible. The char and contamination layers to be removed from the pine wood trusses and plywood sheets covering the ceiling were from 5 to 75 mils thick. Moore Restoration's decision to use Silver Sponge Media™ #80-grit abrasive and the Sponge-Jet Sponge Blasting™ System to restore the surface was based on a few key challenges:

Moore Restoration blasted 13,000 ft² (1,208 m²) of wood trusses and plywood-ceiling surfaces as specified. Operators blasted 10 ft²/minute (56 m²/hr), which was twice as fast as estimated. Abrasive media consumption was cut by reusing Silver Sponge Media™ abrasive 12 times. The Sponge Blasting™ System cut downtime, allowing the glass plant to reopen earlier than planned. Moore's project manager noted, "even though the wood was roughened, it was fully cleaned of all coating, char and soot - posing no problem for repainting."
